DEPARTMENT OF TRANSPORTATION

Contract #: 04-0120F4Cty: SF/ALA Rte: 80 PM: 13.2/13.9File #: 99.28**WELDING INSPECTION REPORT****Resident Engineer:**Siegenthaler, Peter**Address:** 333 Burma Road**City:** Oakland, CA 94607**Report No:** WIR-019318**Date Inspected:** 02-Jan-2011**Project Name:** SAS Superstructure**OSM Arrival Time:** 700**Prime Contractor:** American Bridge/Fluor Enterprises, a JV**OSM Departure Time:** 1900**Contractor:** Zhenhua Port Machinery Company, Ltd (ZPMC) Chanxing Island**Location:** Shanghai, China

Bridge No: 34-0006**Component:** OBG Segment**Summary of Items Observed:**

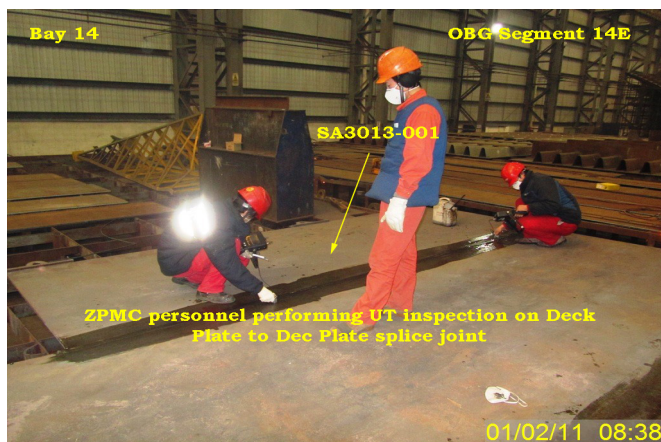
This QA inspector observed ZPMC personnel performed Ultrasonic Testing on Deck Plate to Dec Plate joint of the OBG Segment 14E and the weld is identified as SA3013-001. See the attached picture.
